### TRANSPORTATION RESEARCH CENTER

Indiana University

# ON-SITE AIR BAG FIRE INVESTIGATION

CASE NO. - 94-16
FLEET - PRIVATE VEHICLE
LOCATION - SELECTION, WISCONSIN
ACCIDENT DATE - 1994

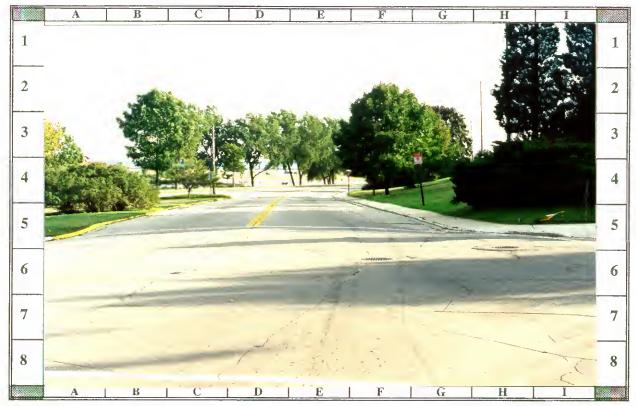
# 04 - 1995 Plymouth Neon's south-southeastward downhill travel path ~ five meters north of initial impact with 1986 Dodge Omni

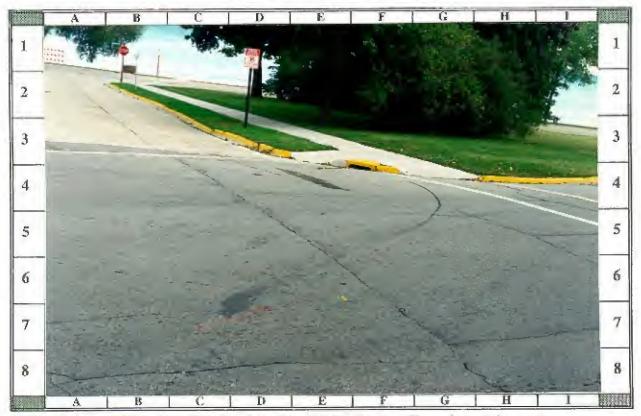
# 11 -- 1986 Dodge Omni's right front deflection/scuff mark post-impact looking east-southeast; NOTE: 1995 Neon's spill (cells D4--E4)

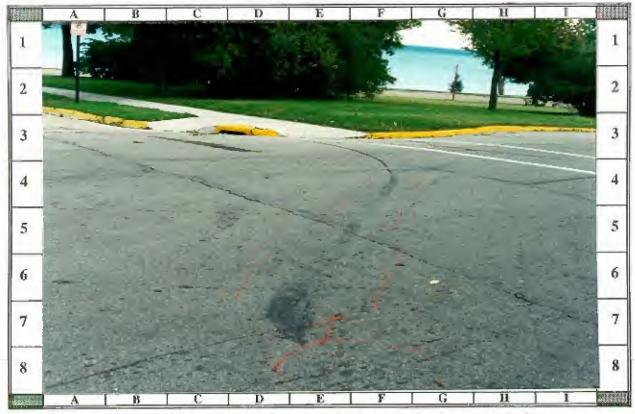
# 12 — Close-up of 1986 Dodge Omni's right front deflection point & SE post-impact travel path; NOTE: 1995 Neon's spill (cells B3-D3)

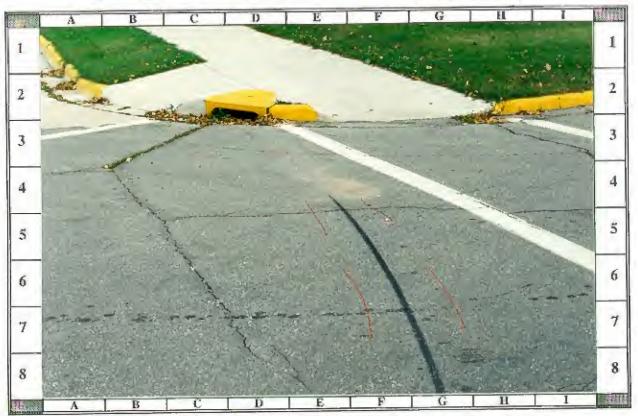
# 13 -- Close-up of 1986 Dodge Omni's right front scuff mark & southeast post-impact travel path; NOTE: 1995 Neon's spill (cells B2--C3)

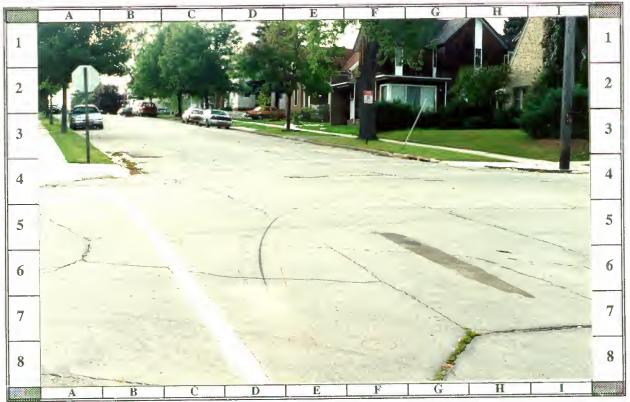
# 15 -- Close-up of amber turn signal debris most likely from 1995 Plymouth Neon--looking north-northeast; NOTE: spurious tire marks

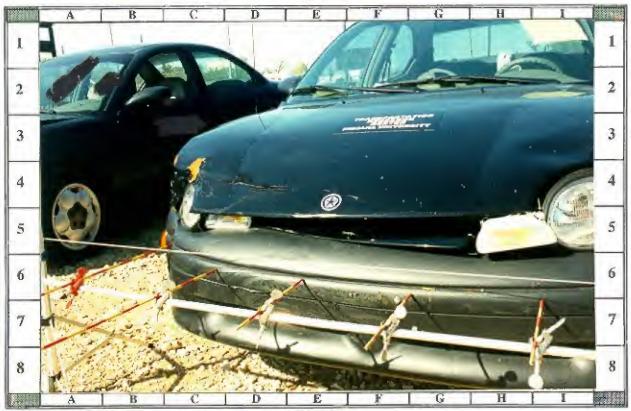
# 18 -- 1995 Plymouth Neon's frontal damage with contour guage present; viewed from front

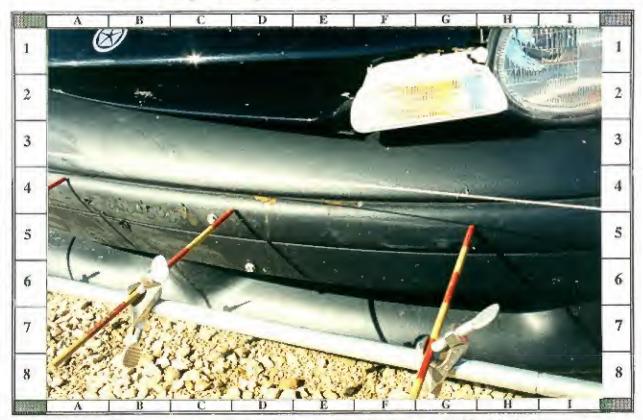
# 19 -- Close-up of direct damage to '95 Plymouth Neon's front bumper, hood, and right headlight assembly

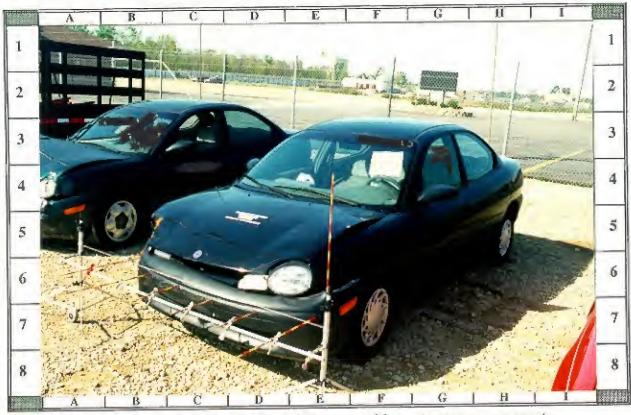
# 20 -- Closer-up of end of direct damage to 1995 Plymouth Neon's front bumper; NOTE: induced damage to left headlight assembly

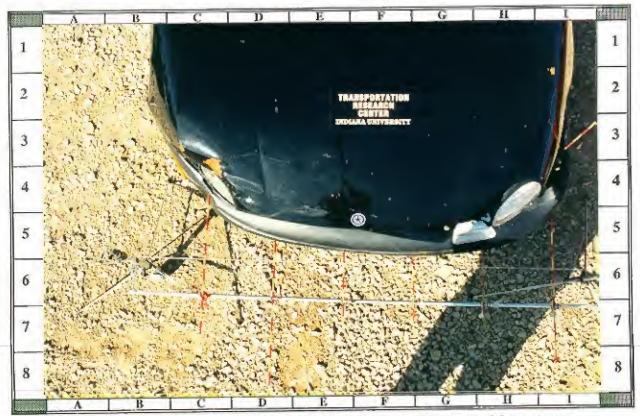
# 21 -- 1995 Plymouth Neon's frontal damage with contour guage present; viewed from front left

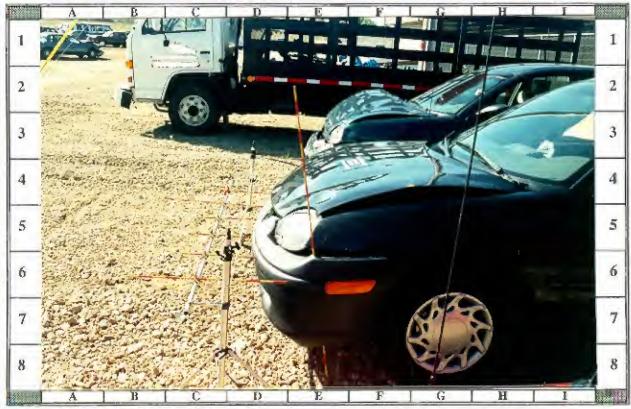
# 22 - Overhead view of '95 Plymouth Neon's frontal damage with contour guage present; viewed from front

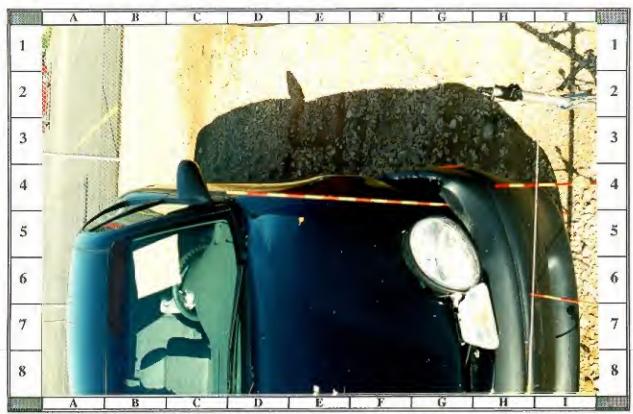
# 23 -- 1995 Plymouth Neon's frontal damage with contour guage present; viewed across front from left; NOTE: induced damage to hood

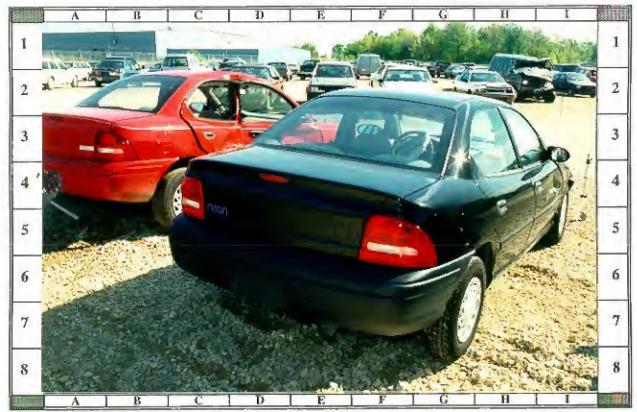
# 25 -- 1995 Plymouth Neon's undamaged left side and rear viewed from left rear

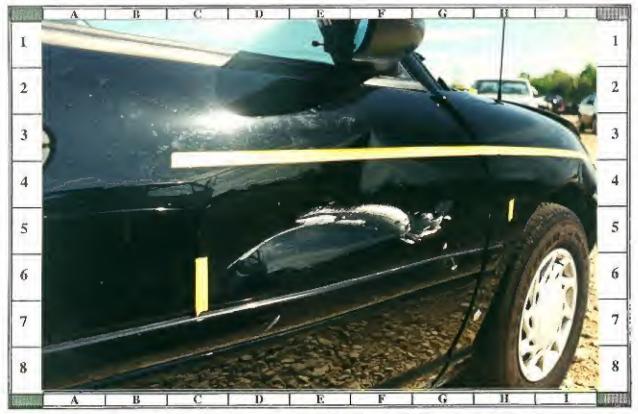
# 27 -- 1995 Plymouth Neon's right side showing sideslap damage to right front fender, door, and outside rearview mirror

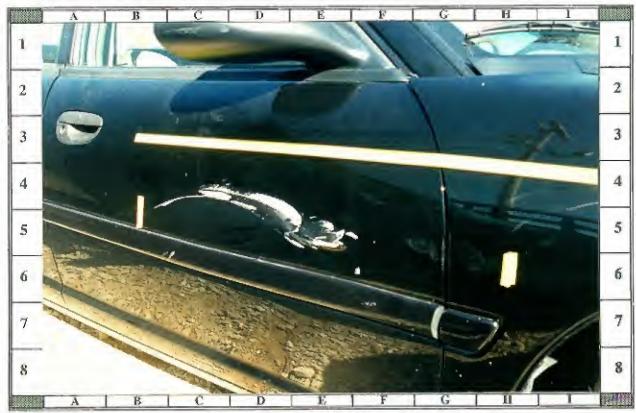
# 28 -- Close-up of sideslap damage to 1995 Plymouth Neon's right front door viewed from right rear

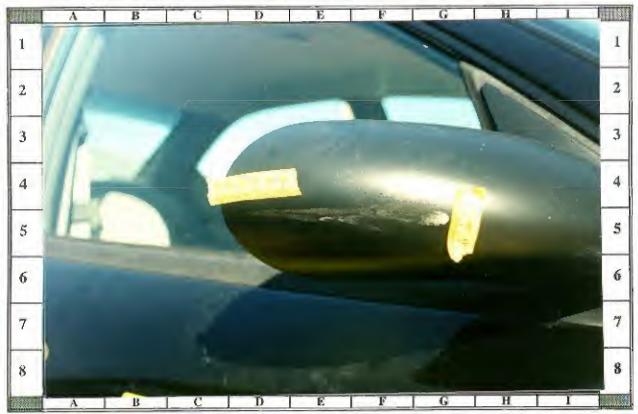
# 29 -- Close-up of sideslap damage to 1995 Plymouth Neon's right front door and rearview mirror (cells B1--C1) viewed from right front

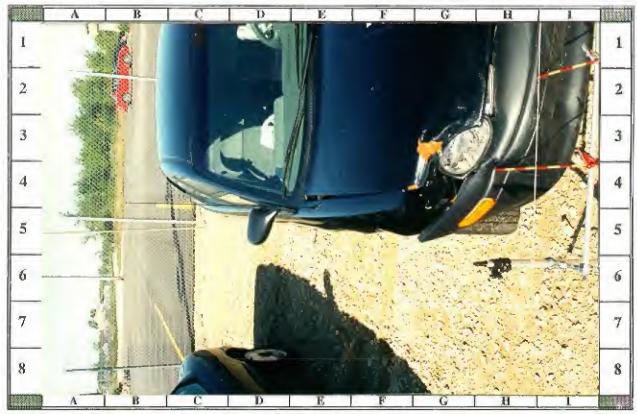
# 31 - 1995 Plymouth Neon's frontal damage with contour guage present; viewed across front from right; NOTE: snag at RF bumper corner

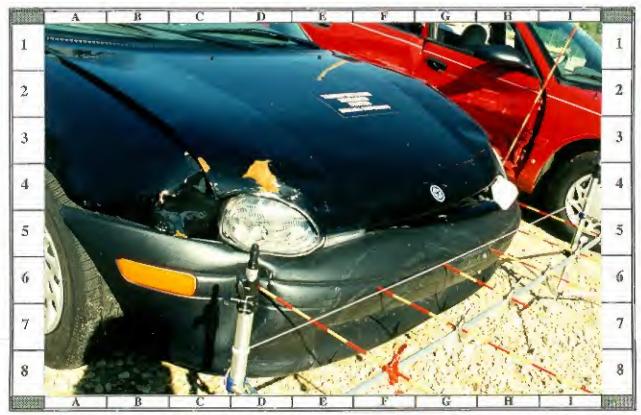
# 32 -- 1995 Plymouth Neon's right side viewed along right side from front; NOTE: damage to right headlight assembly and bumper snag

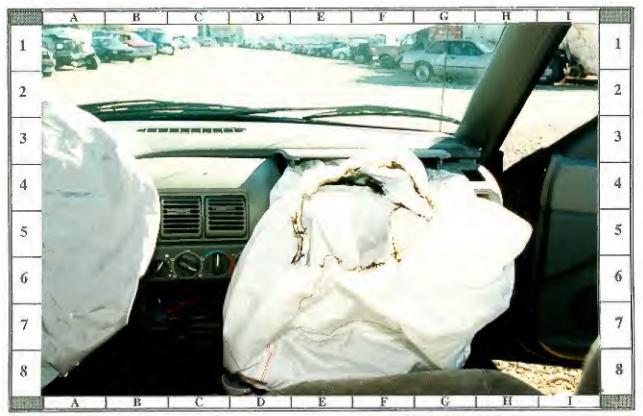
# 38 -- 1995 Plymouth Neon's middle and right dash and right toepan area viewed from right front door; NOTE: no contact evidence/radio

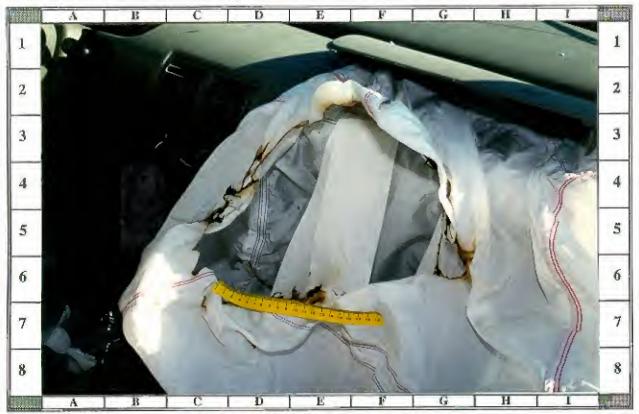
Concerning the post-deployment air bag fire, it must be noted that at no time was there any flame (fire) observed. The extreme heat from the exhaust cannister caused the surrounding air bag material to subsequently melt causing the excessive smoke reported by both drivers and fire personnel. No evidence of flame (fire) damage was found near the air bag, windshield, or dashboard areas during this contractor's vehicle inspection.

# 39 -- 1995 Plymouth Neon's right front passenger air bag showing large burn hole in air bag

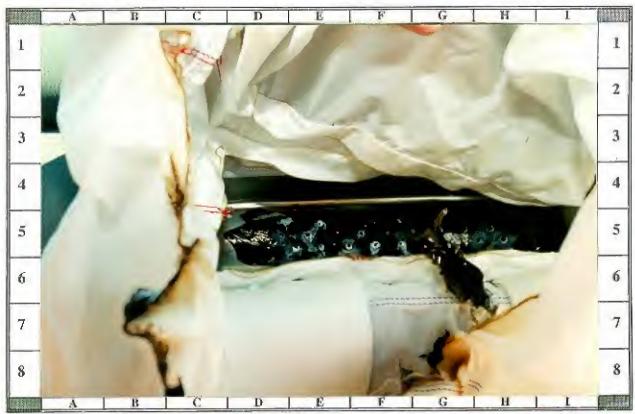
# 41 -- Close-up of burn mark on 1995 Plymouth Neon's right front passenger air bag tether; NOTE: burn marks around hole's periphery

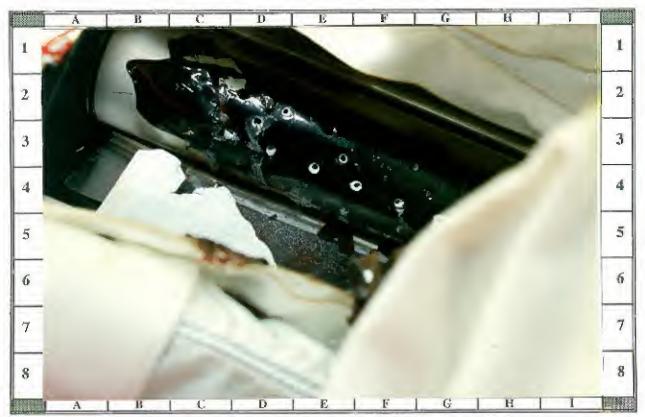
# 42 -- Close-up of 1995 Plymouth Neon's right front passenger air bag inflator assembly; NOTE: melted bag material around inflator

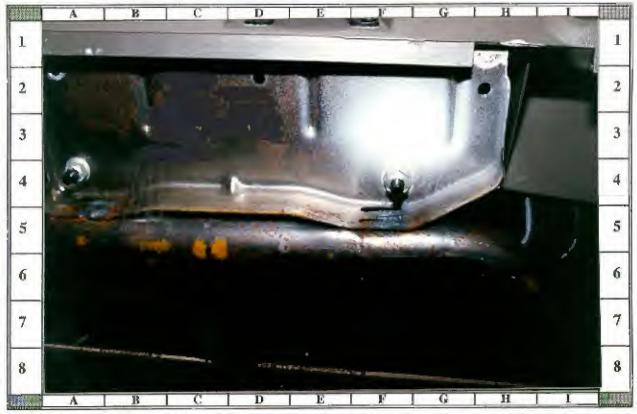
# 43 - Close-up of 1995 Plymouth Neon's RF passenger air bag inflator assembly; NOTE: singed paper-like material next to inflator

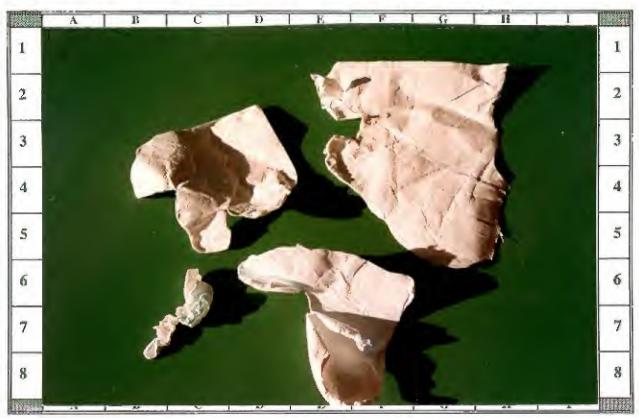
# 44 — Close-up of 1995 Plymouth Neon's right front passenger air bag Reaction Can taken from underneath right front dash

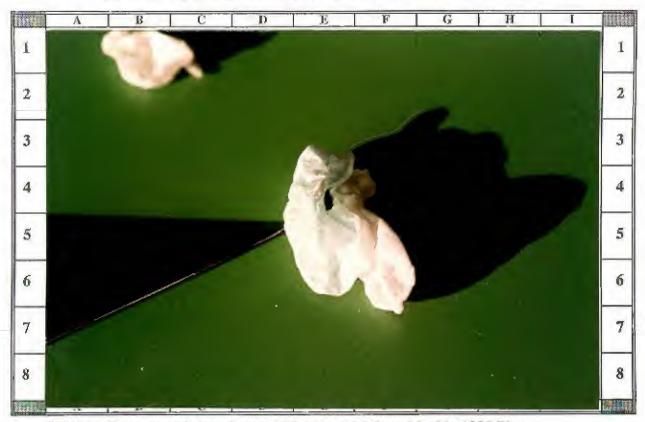
# 45 — Close-up of singed paper-like material found inside '95 Plymouth Neon's RF passenger air bag; see photo #43 above-cells B3-D5

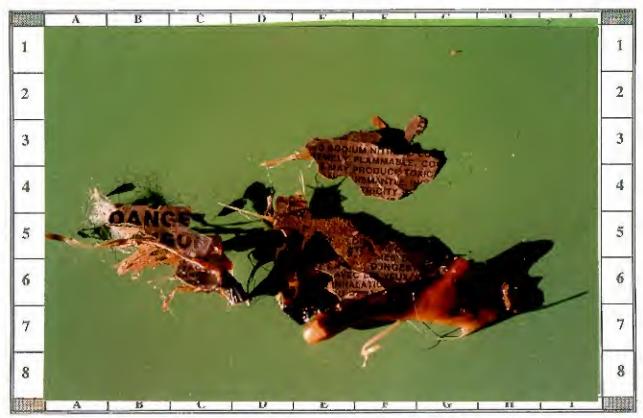
# 46 -- Closer-up of singed paper-like material found inside 1995 Plymouth Neon's right front passenger air bag; NOTE: bluish tinge

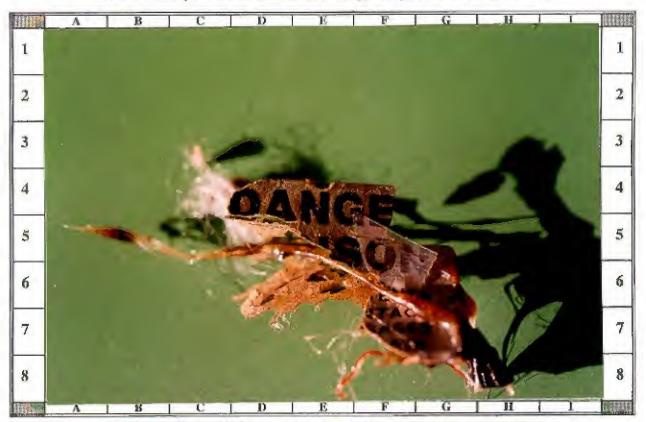
# 47 -- Close-up of warning label attached to melted material found inside 1995 Plymouth Neon's RF air bag; see photo #42 cells F5--G5

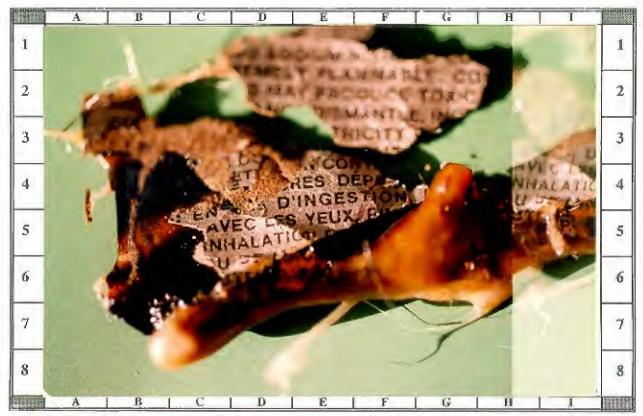
# 48 -- Closer-up view of left-half of warning label attached to melted material found inside 1995 Plymouth Neon's right front air bag

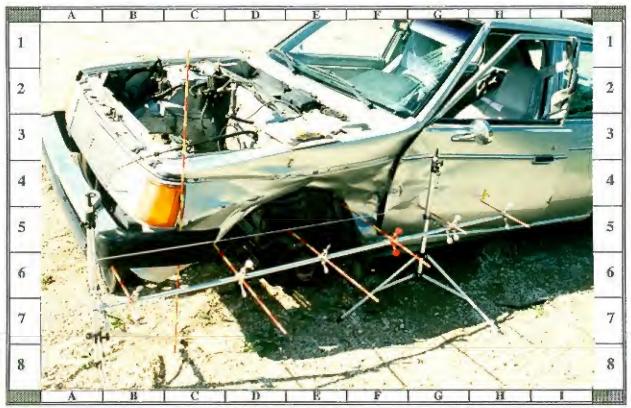
# 54 -- 1986 Dodge Omni's undamaged front viewed from front; NOTE: engine, hood, and both front wheels have been removed

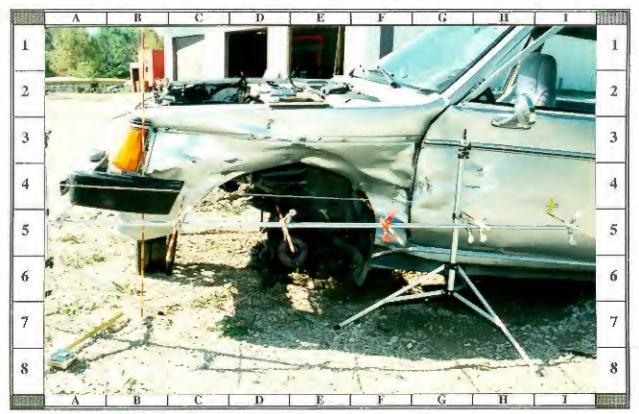
# 55 -- 1986 Dodge Omni's left front direct damage with contour guage present viewed from left front; NOTE: engine removed

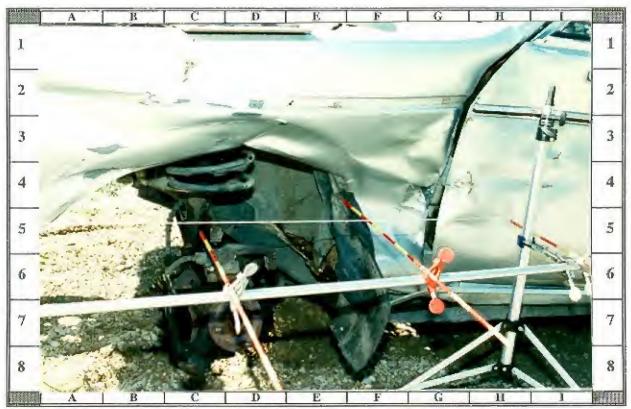
# 56 -- 1986 Dodge Omni's left front direct damage with contour guage present viewed from left; NOTE: front tires removed

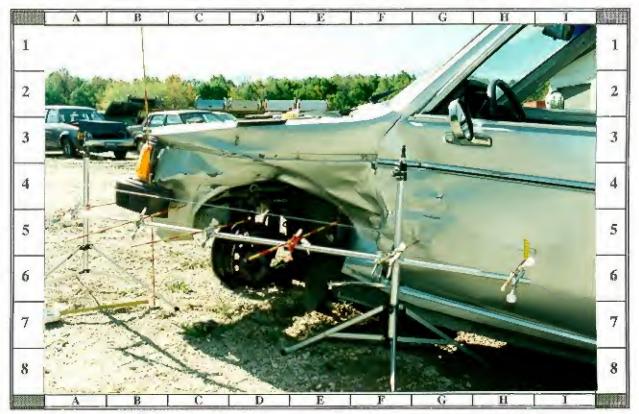
# 57 -- Close-up of 1986 Dodge Omni's left front damage at area of maximum crush (red clamp); NOTE: wheels gone and snagging near door

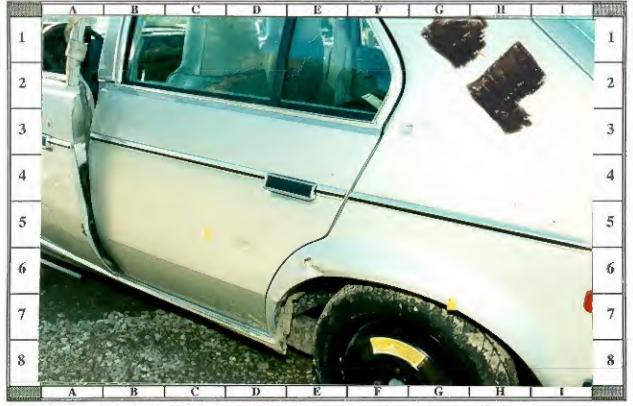
# 59 - 1986 Dodge Omni's sideslap damage to left rear door and quarter panel viewed from left front

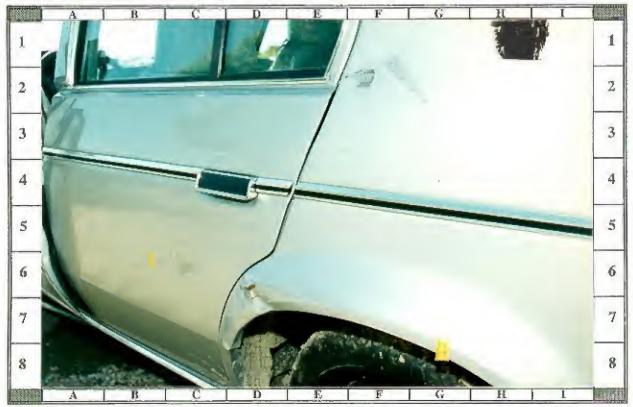
# 60 - 1986 Dodge Omni's sideslap damage to left rear door and quarter panel viewed from left rear

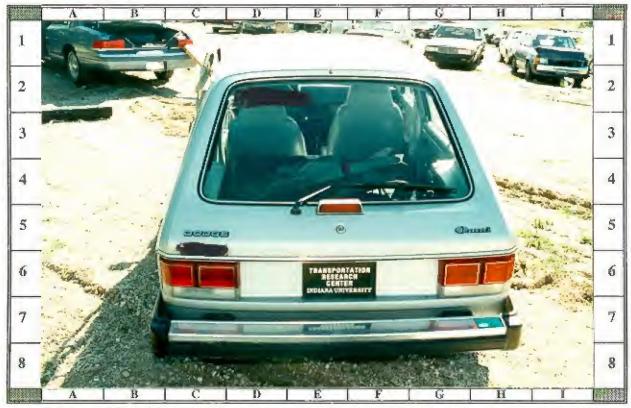
# 62 -- 1986 Dodge Omni's damaged left side & undamaged rear viewed from rear left; NOTE: rear tires replaced with temporary spare tires

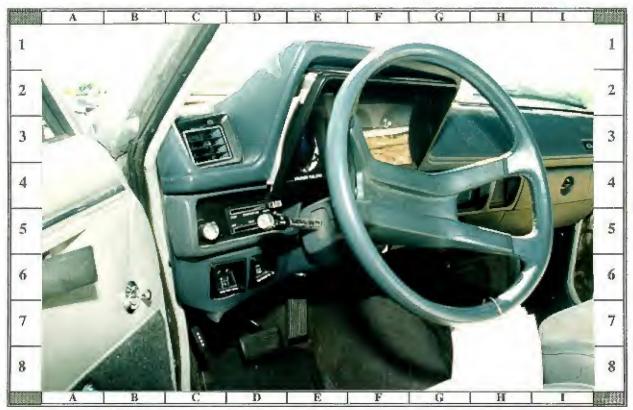
# 66 -- 1986 Dodge Omni's left front interior door surface and driver seating area; NOTE: no evidence of driver contact

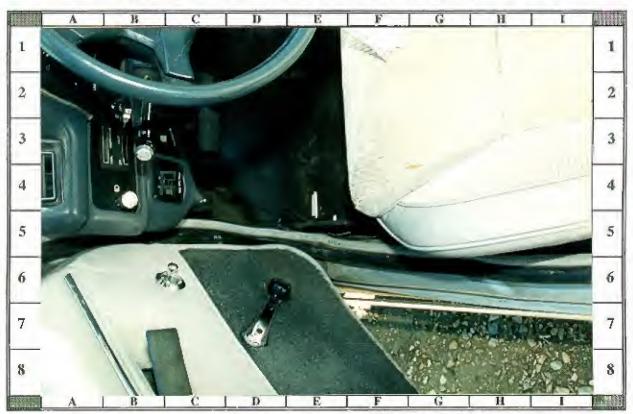
# 67 -- Close-up of 1986 Dodge Omni's driver steering assembly, left dash, & toepan area; NOTE: induced dash damage from intrusion

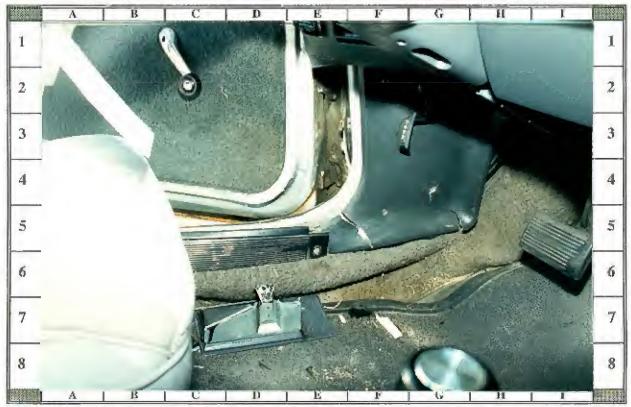
# 68 -- Overhead view of 1986 Dodge Omni's left door sill and dash deformed by intrusion-viewed from left front door area

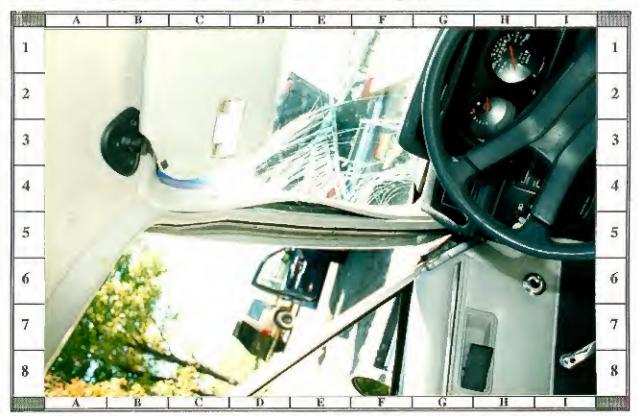
# 69 -- Close-up of 1986 Dodge Omni's left kickpanel & door sill damaged by intrusion--viewed from right front seating area

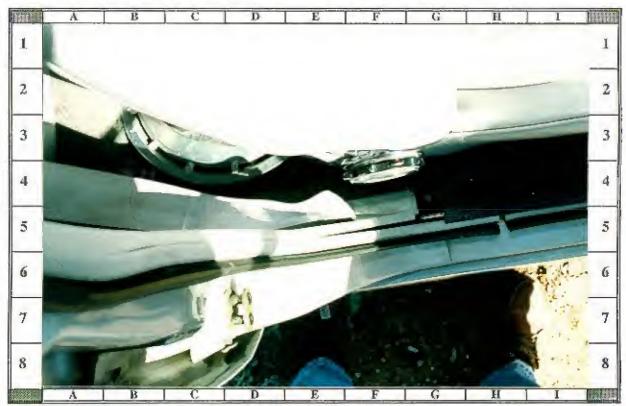
# 71 -- Overhead view of 1986 Dodge Omni's intrusion to left front door sill & movement of driver's seat; NOTE: seat adjuster (cell E5)

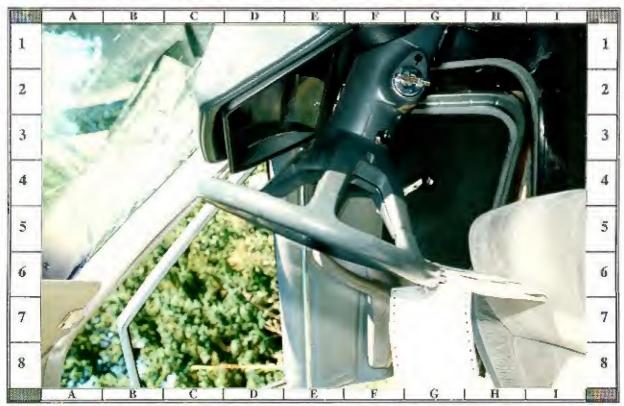
# 73 -- 1986 Dodge Omni's steering wheel, left interior door surface, and dash viewed from rear center; NOTE: no contact evidence

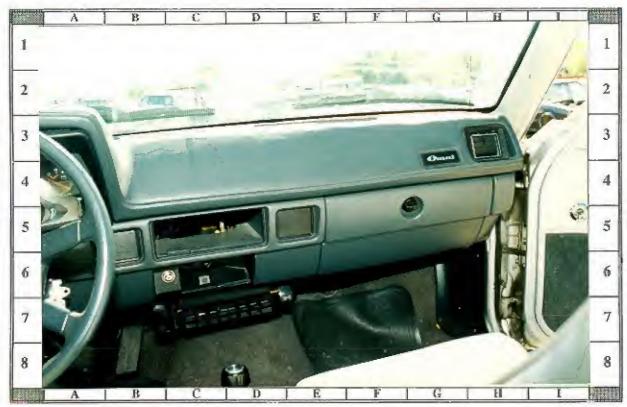
# 74 -- 1986 Dodge Omni's undeformed steering wheel viewed from right front seating area

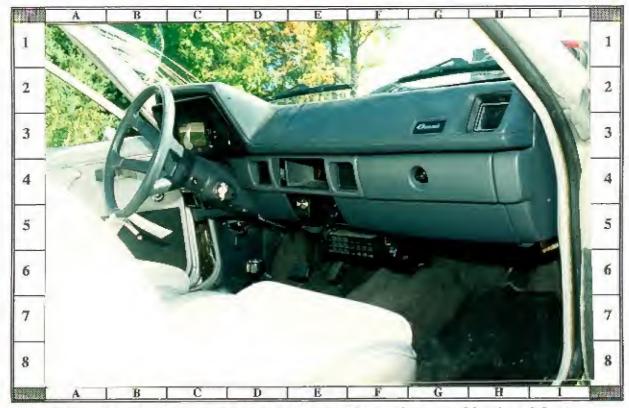
# 75 - 1986 Dodge Omni's undamaged center and right dash, toepan, and windshield, and lower right A-pillar viewed from rear center

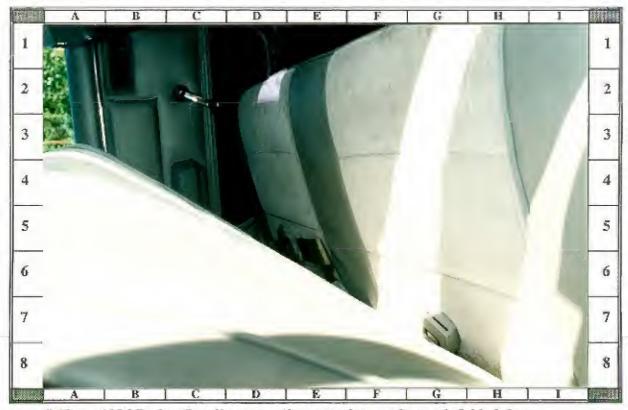
# 77 -- 1986 Dodge Omni's front seatbacks viewed from right rear door area; NOTE: rear seat back was folded down
